# **EVALUATION OF THE STRUCTURAL INTEGRITY OF AN AIRCRAFT LOADING WALKWAY UNDER SEVERE FUEL-SPILL FIRE CONDITIONS**

**FINAL REPORT**

1. Report No. FAA-RD-73-144		2. Government Accession No.		3. Recipient's Catalog No.	
4. Title and Subtitle EVALUATION OF THE STRUCTURAL INTEGRITY OF AN AIRCRAFT LOADING WALKWAY UNDER SEVERE FUEL-SPILL FIRE CONDITIONS				5. Report Date October 1973

6. Performing Organization Code	
7. Author(s) George B. Geyer, Lawrence M. Neri, Charles H. Urban				8. Performing Organization Report No. FAA-NA-73-79

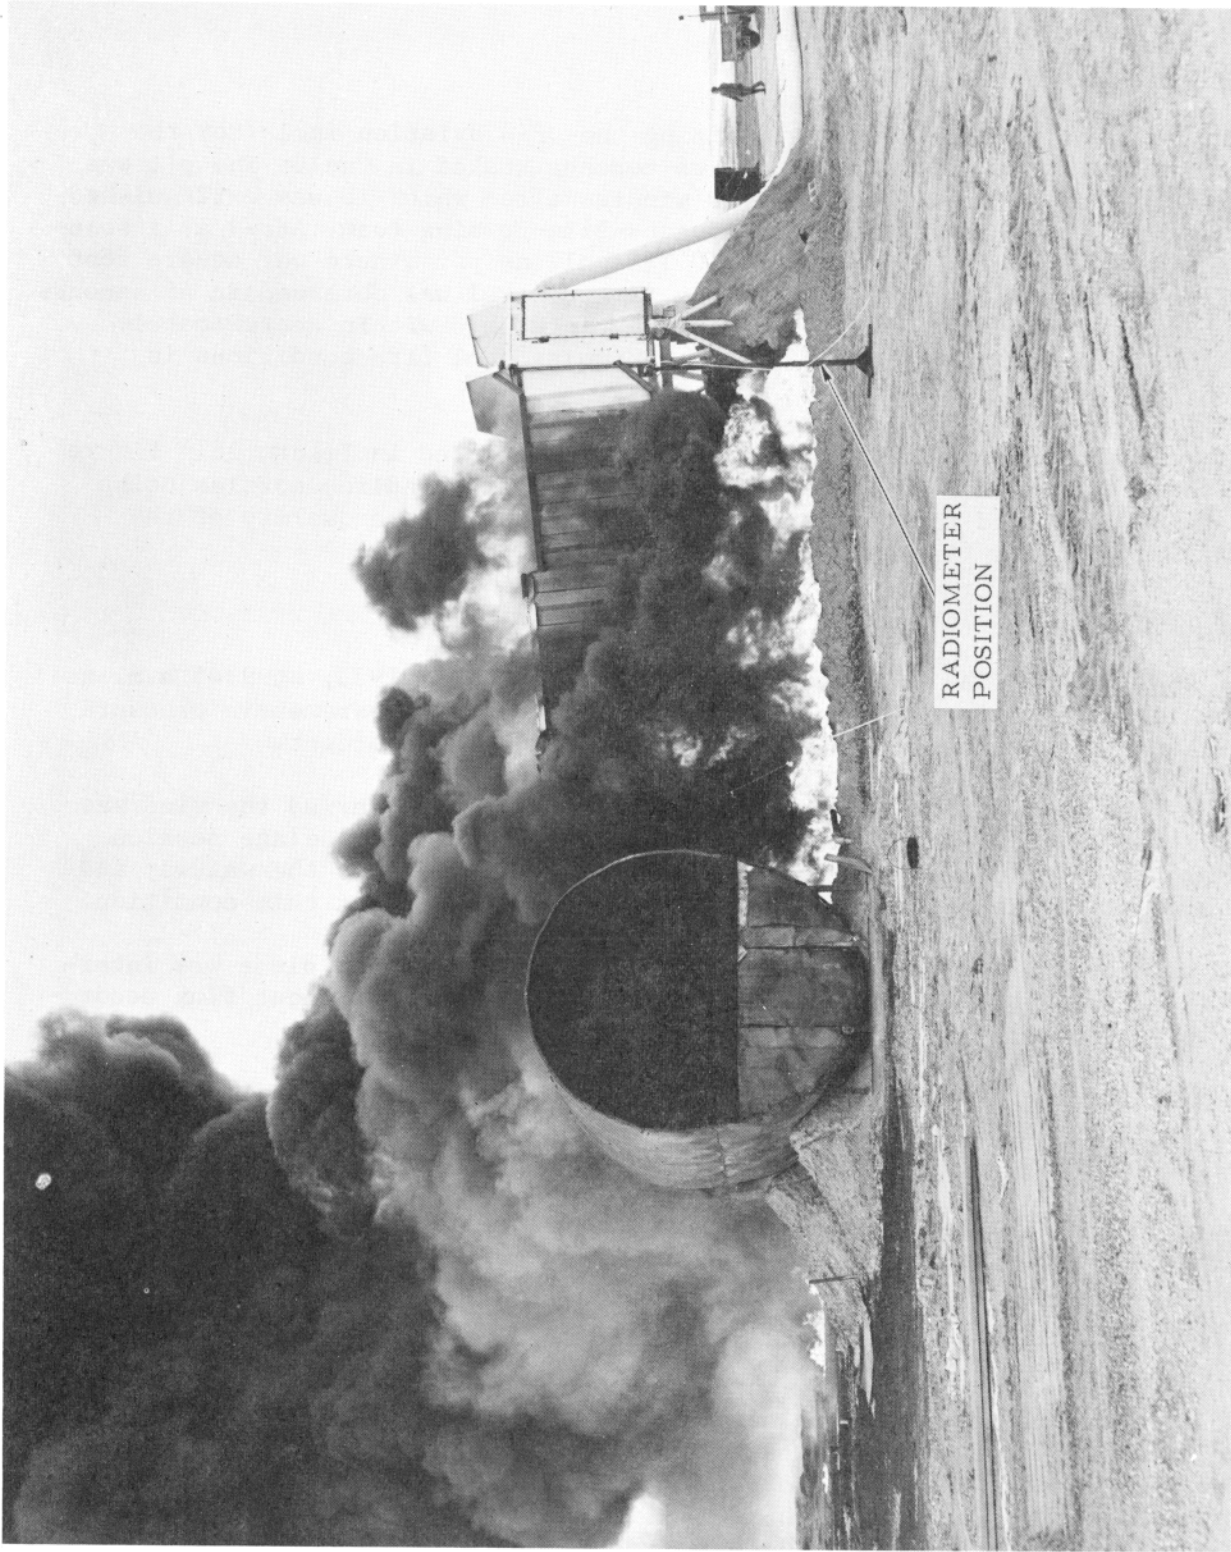
The experiment was initiated by igniting the JP-4 aviation fuel from the upwind side of the pit by means of two torches soaked in fuel. The pit was then permitted to burn freely for 10 minutes after which it was extinguished by two handlines each discharging Aqueous-Film-Forming Foam (AFFF) at a solution rate of 60 gallons per minute (0.125 gallons per minute per square foot of fire area). Under these conditions fire control was obtained in 45 seconds (90-percent reduction in heat flux) and extinguished within approximately 65 seconds. A typical view of the free-burning pool fire conditions is shown in Figure 17.

FIGURE 17. TYPICAL FREE-BURNING POOL-FIRE CONDITIONS

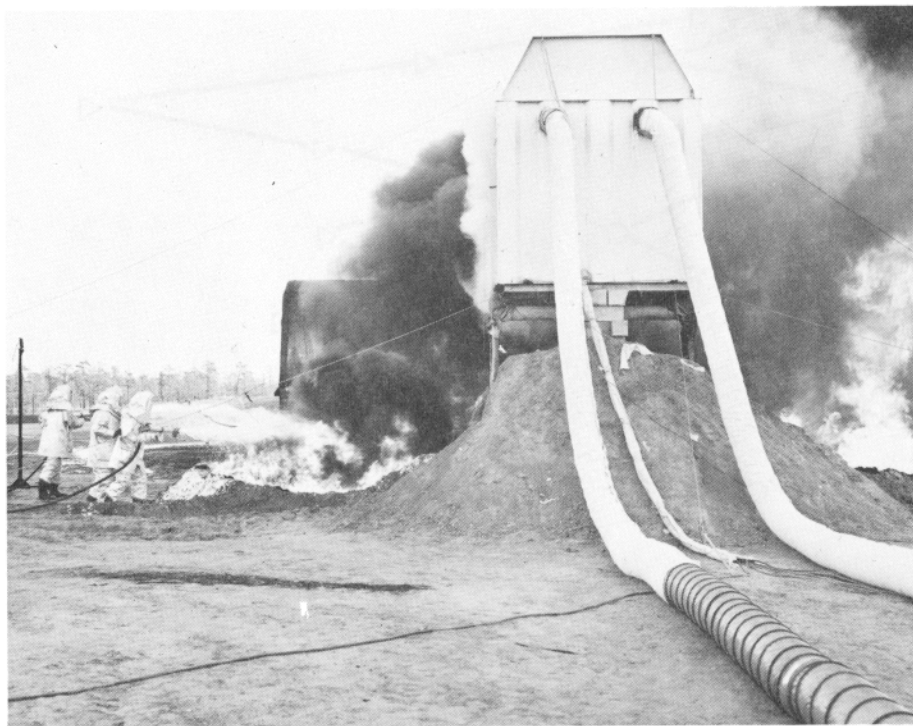
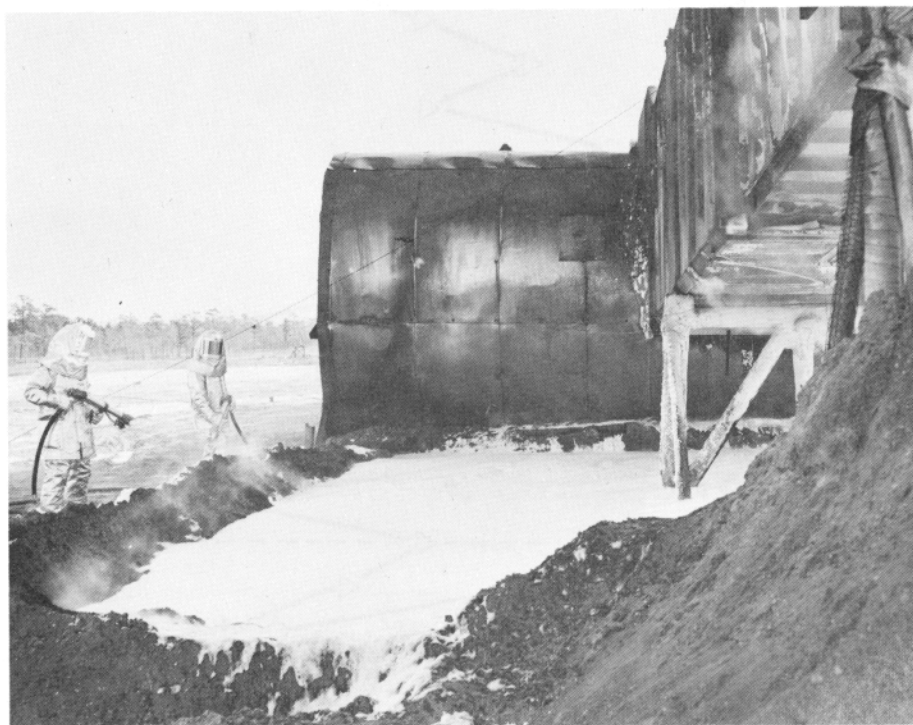
a. Initial Attack With Foam/Water Handlines.

b. AFFF Blanket After Fire Extinguishment.

FIGURE 18. CRITICAL PHASES DURING THE FIREFIGHTING OPERATION

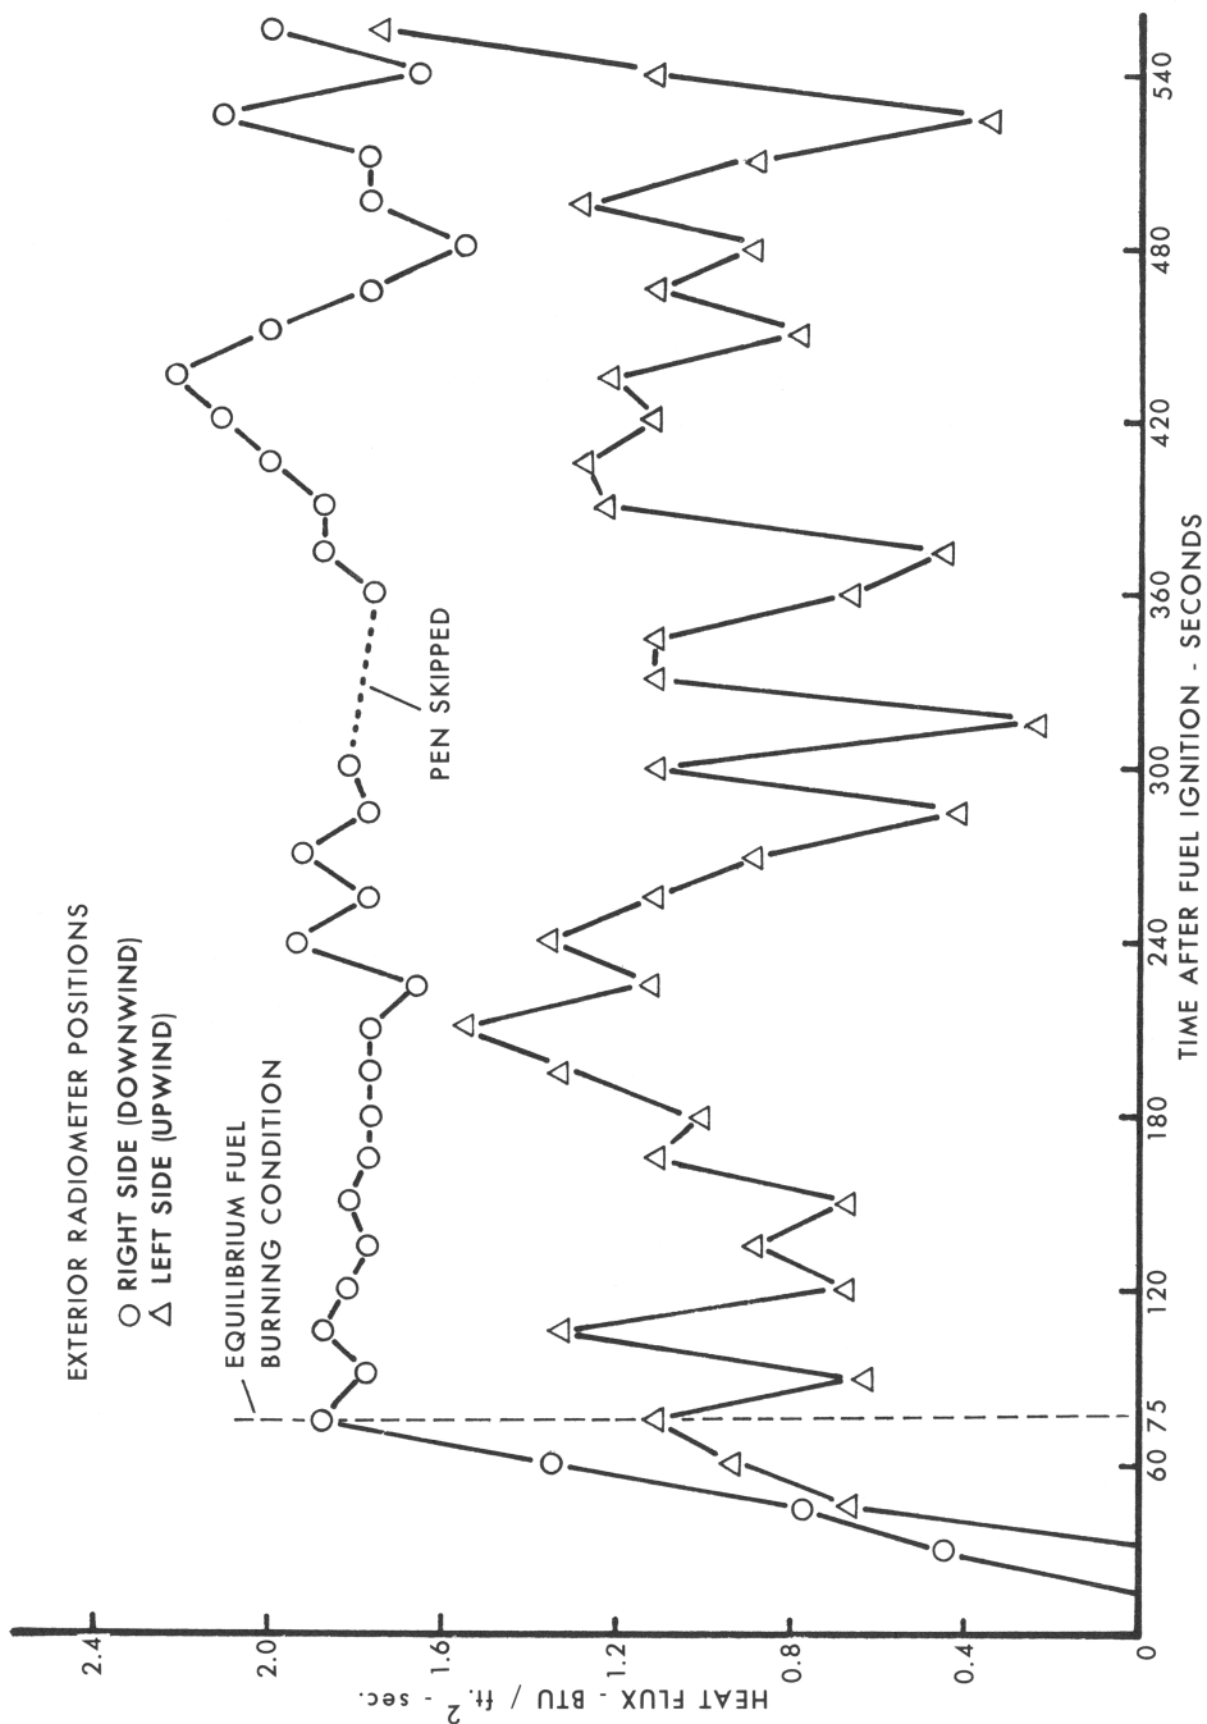
The profiles in Figure 19 show the heat flux as a function of time after fuel ignition and indicate that the time required to reach equilibrium burning conditions was approximately 75 seconds.

FIGURE 19. EXTERIOR RADIOMETER PROFILES SHOWING HEAT FLUX AS A FUNCTION OF TIME AFTER FUEL IGNITION

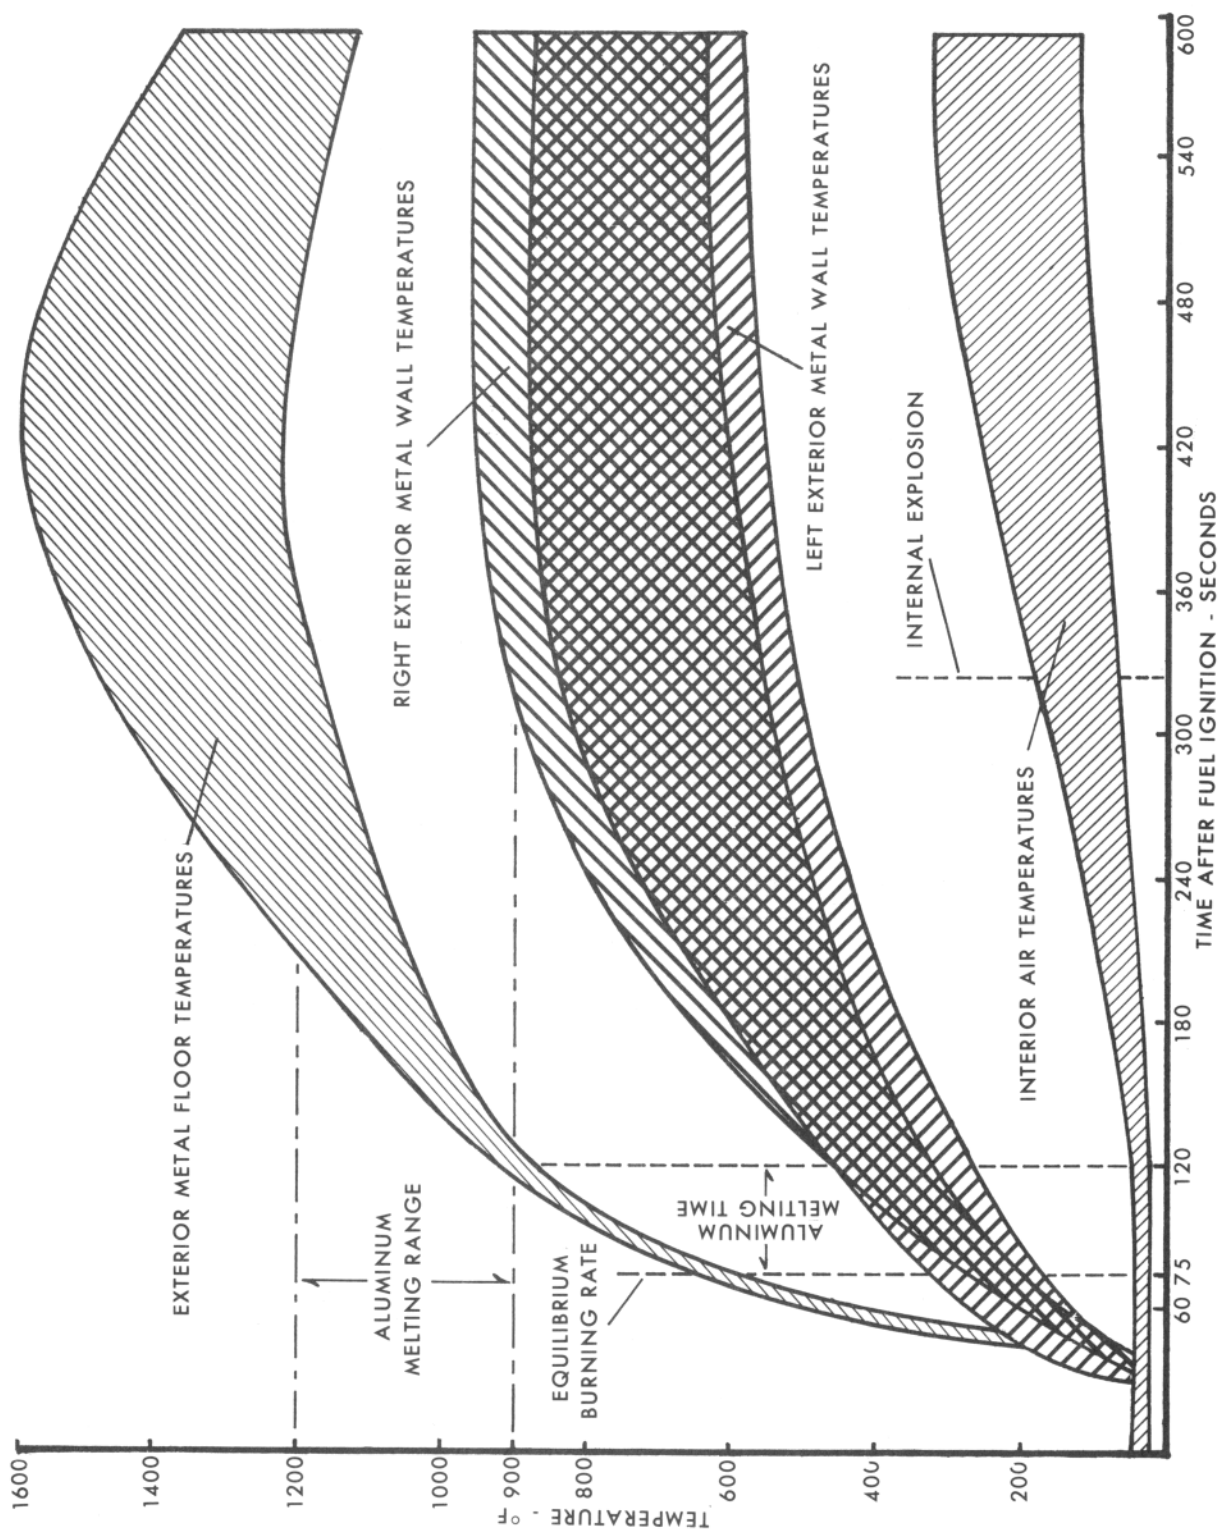
The top envelope encloses all of the time-temperature data developed for the exterior steel floor during fire exposure. The horizontal dashed lines at 900° and 1,200°F were drawn to indicate the melting range for aircraft aluminum which may be considered critical temperatures in any aircraft environment involving fire. The envelope shows that the steel reached the incipient melting temperature for aluminum of 900°F in approximately 45 seconds after equilibrium burning conditions were established which closely approximates the value developed in a previous project under free-burning pool fire conditions (Reference 2).

The bottom envelope encloses all of the time-temperature data obtained at the interior air thermocouple positions. The maximum air temperature after equilibrium burning conditions were established was 245°F at 465 seconds and 220°F within 300 seconds.

Based upon data provided in the U.S. Air Force "Flight Surgeon's Manual" for proficient human performance at elevated air and wall temperatures in equilibrium, it was estimated that the maximum limits of exposure to temperatures of 220°F and 245°F would be approximately 15 minutes and 13 minutes, respectively. Since it was determined that it required approximately 13 seconds to traverse the walkway at a normal walking stride, it is apparent that the environmental air temperature alone would not be a limiting factor in providing a safe egress route.

FIGURE 20. SUMMARY OF THE TIME-TEMPERATURE DATA OBTAINED FOR THE AIRCRAFT LOADING WALKWAY DURING FIRE EXPOSURE

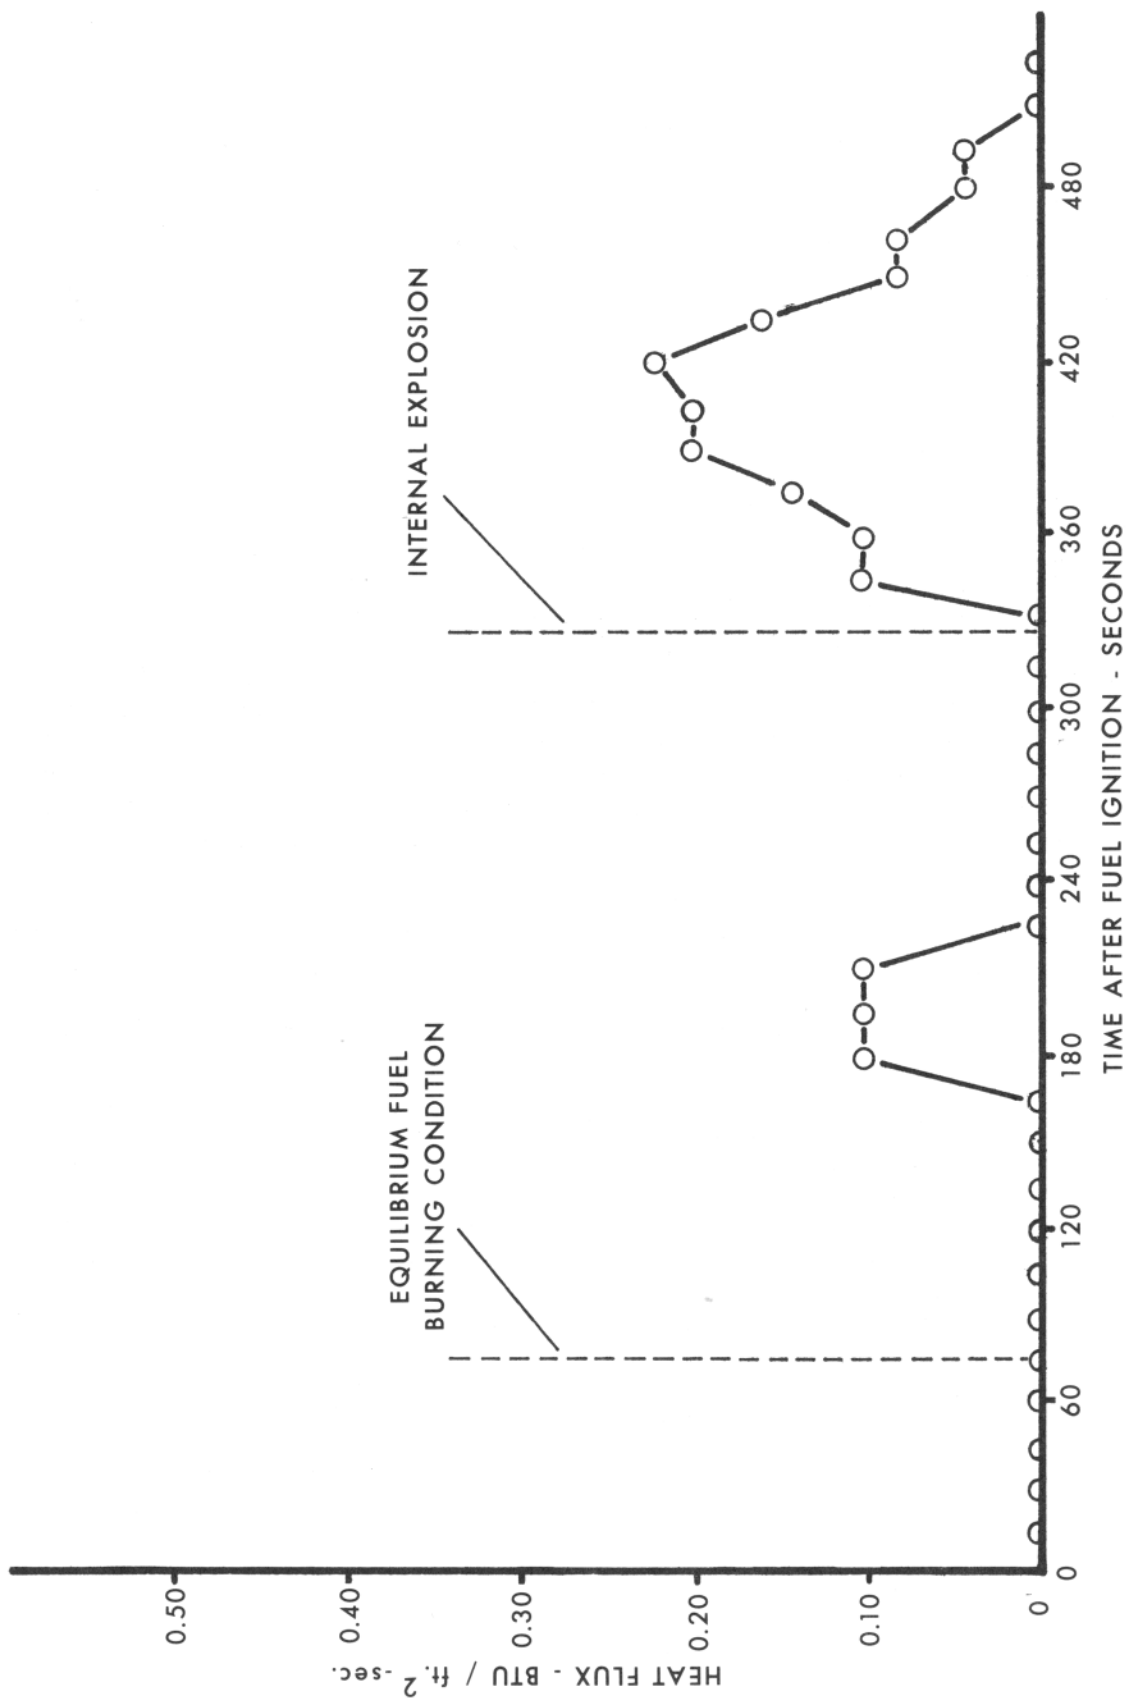
INTERIOR RADIOMETER DATA. The thermal radiation within the walkway is indicated by the profile presented in Figure 22 in which the heat flux is plotted as a function of time after fuel ignition. The profile shows two periods of measurable radiation, the first between 165 and 225 seconds after fuel ignition and the second starting 330 seconds after ignition.

The vertical dashed line drawn at approximately 326 seconds after fuel ignition indicates the instant at which a rather severe internal explosion blew open the steel entrance door in Tunnel A which had been secured by a steel latch. It is speculated that the explosion was caused by ignition of the gaseous pyrolysis products from the plywood floor paneling which completely filled the walkway at that time.

A practical estimation of the intensity of the heat flux developed within the walkway may be made by considering the fact that approximately 0.10 BTU per square foot per second is delivered by the sun, at sea level, during the summer in temperate zones, and that exposure to 0.20 BTU per square foot per second for periods in excess of 30 seconds will cause severe pain in humans.

FIGURE 22. WALKWAY INTERIOR HEAT FLUX AS A FUNCTION OF TIME AFTER FUEL IGNITION

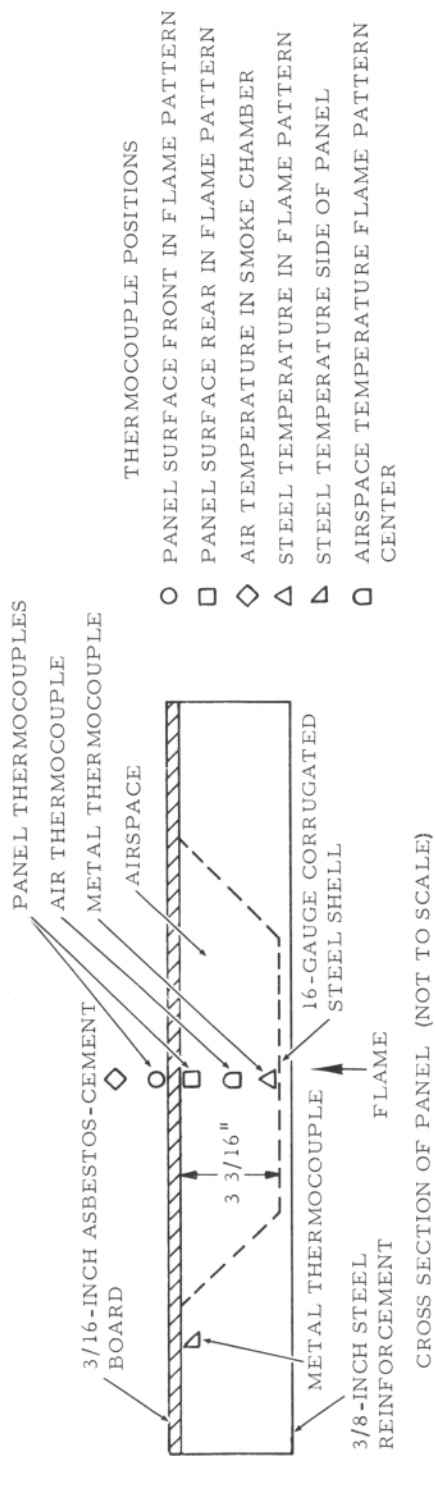
The thermal effects on the test panel during fire exposure are indicated by the profiles in Figure 29 in which temperature is plotted as a function of the flame exposure time.

FIGURE 29. THERMAL EFFECTS ON A REPRESENTATIVE WALL PANEL SECTION WHERE THE CORRUGATED METAL AND ASBESTOS-CEMENT BOARD ARE SEPARATED BY AN AIRSPACE

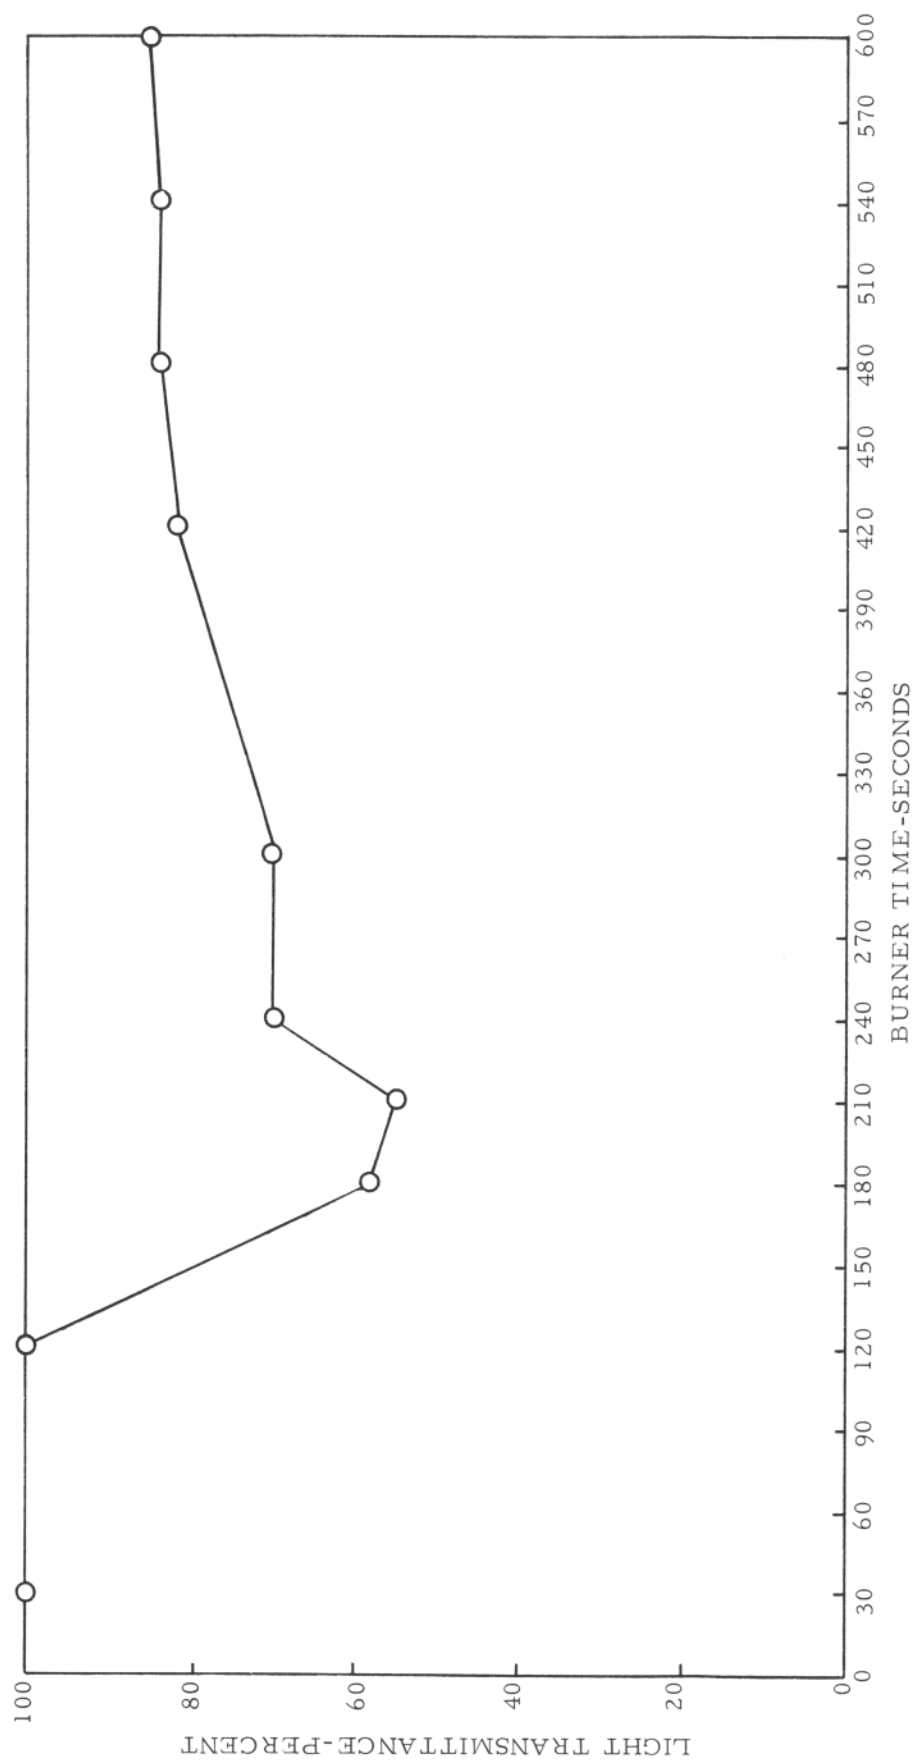
The profile in Figure 30 shows the reduction in transmitted light caused by the smoke generated from the wall panel configuration in the smoke meter housing as a function of time after the start of flame exposure. This profile indicates that no smoke was generated during a period of 120 seconds after the start of flame impingement, after which smoke developed rapidly causing a 65 percent reduction in light transmittance within 210 seconds which decreased to 30 percent within 5 minutes and to 15 percent after 10 minutes.

FIGURE 30. SMOKE GENERATED FROM A WALL PANEL SECTION AS A FUNCTION OF FIRE EXPOSURE TIME

Upon inspection of the wall sample at the conclusion of the experiment, it was apparent that the smoke recorded in the housing derived primarily from the pyrolysis of the adhesive bonding material between the asbestos-cement board and the aluminum retaining strips, which showed extensive charring.

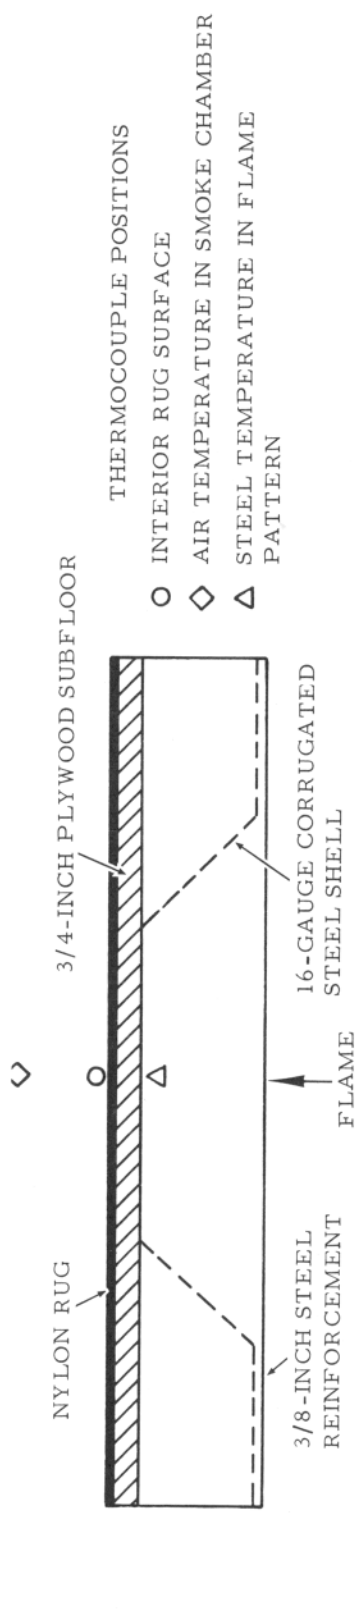
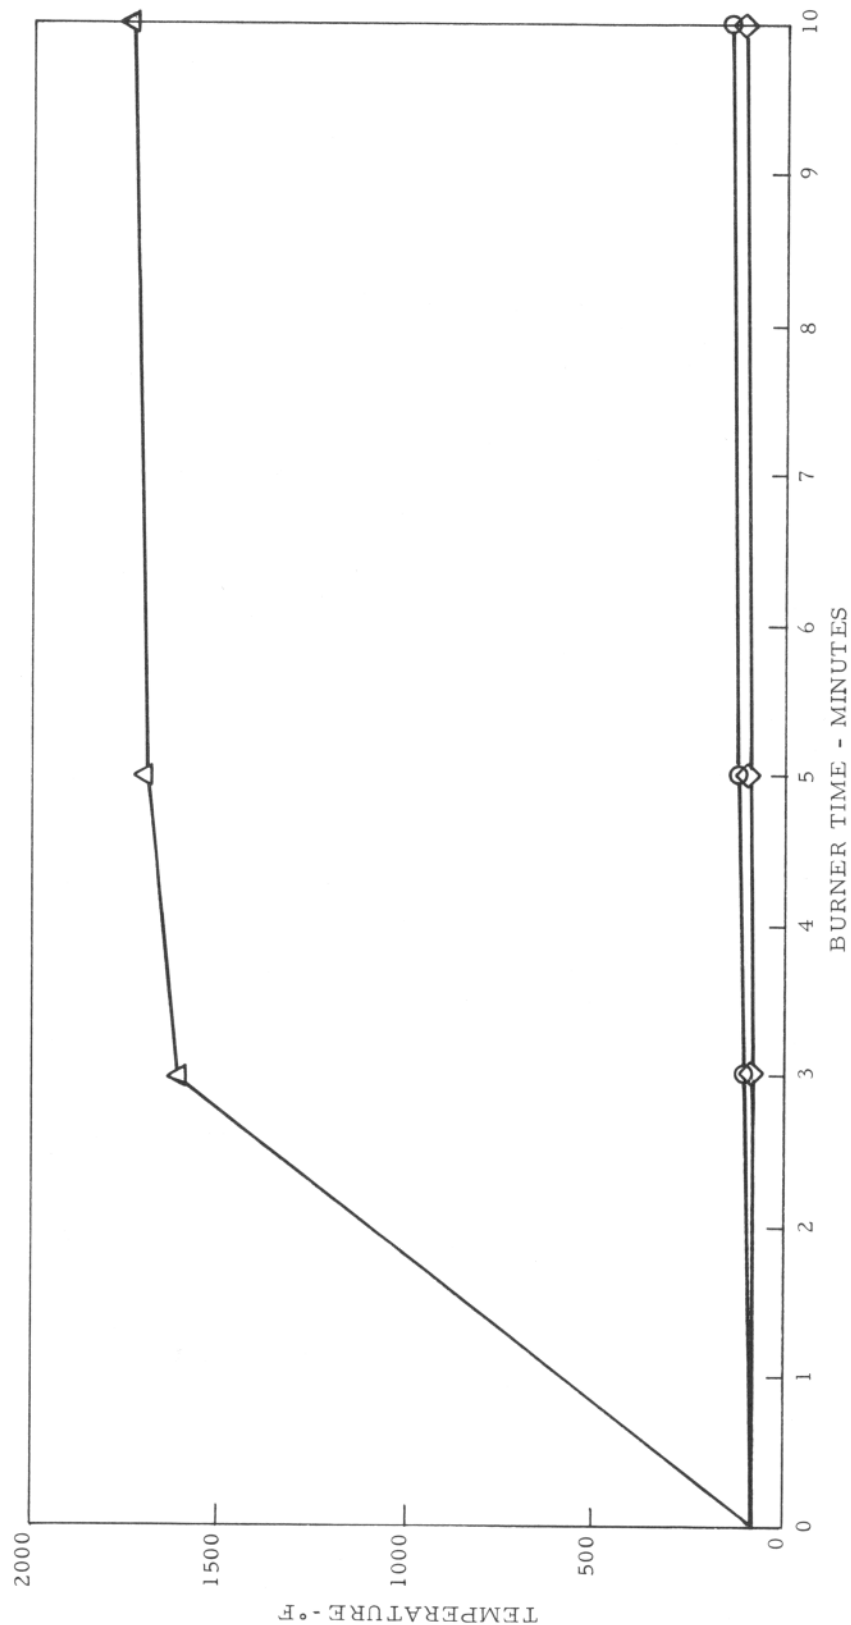
The thermal profiles developed from the test data for each floor configuration are presented in Figures 31 and 32. These data tend to indicate that there were no significant differences in the overall environmental effects produced by the two different test configurations. However, when the metal and plywood flooring were in contact (Figure 31), the rug surface and the air temperature within the housing were slightly higher (approximately 10°F) than when they were separated by the airspace.

FIGURE 31. THERMAL EFFECTS ON A REPRESENTATIVE WALKWAY FLOOR PANEL WHERE THE CORRUGATED METAL AND PLYWOOD ARE ADJACENT TO ONE ANOTHER

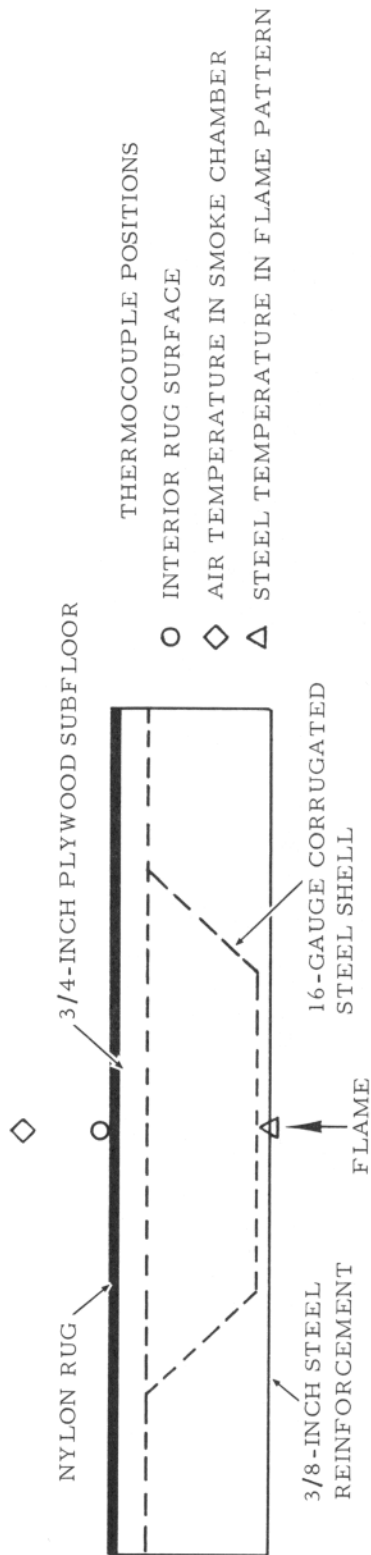
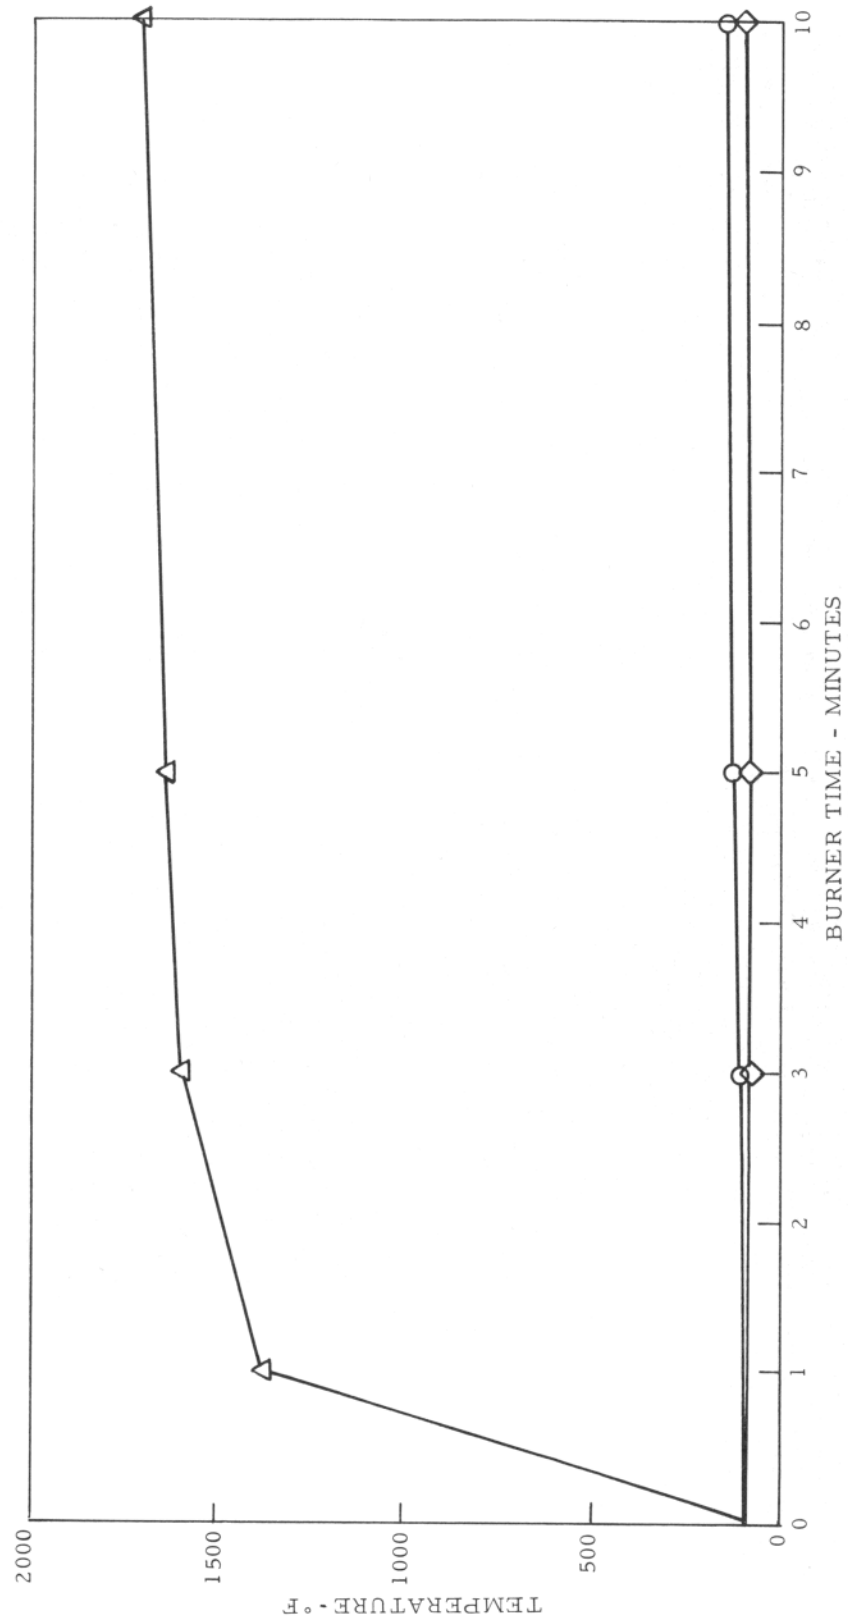
During fire exposure, copious quantities of smoke and gas were generated from both floor configurations caused by the pyrolysis of the plywood flooring, which ultimately escaped from the edges of the closure into the atmosphere. However, no smoke penetrated through the floor structure into the chamber containing the smoke meter when the steel and plywood were separated by an airspace (Figure 32) but, approximately 5 percent light obscuration was noted when the metal and plywood were in contact (Figure 31). No damage to the carpet was visible with either structural configuration after the test. Figure 33 shows the charred condition of the plywood flooring after flame exposure for the panel configuration shown in Figure 32.

FIGURE 32. THERMAL EFFECTS ON A REPRESENTATIVE WALKWAY FLOOR PANEL WHERE THE CORRUGATED METAL AND PLYWOOD FLOORING ARE SEPARATED BY AN AIRSPACE

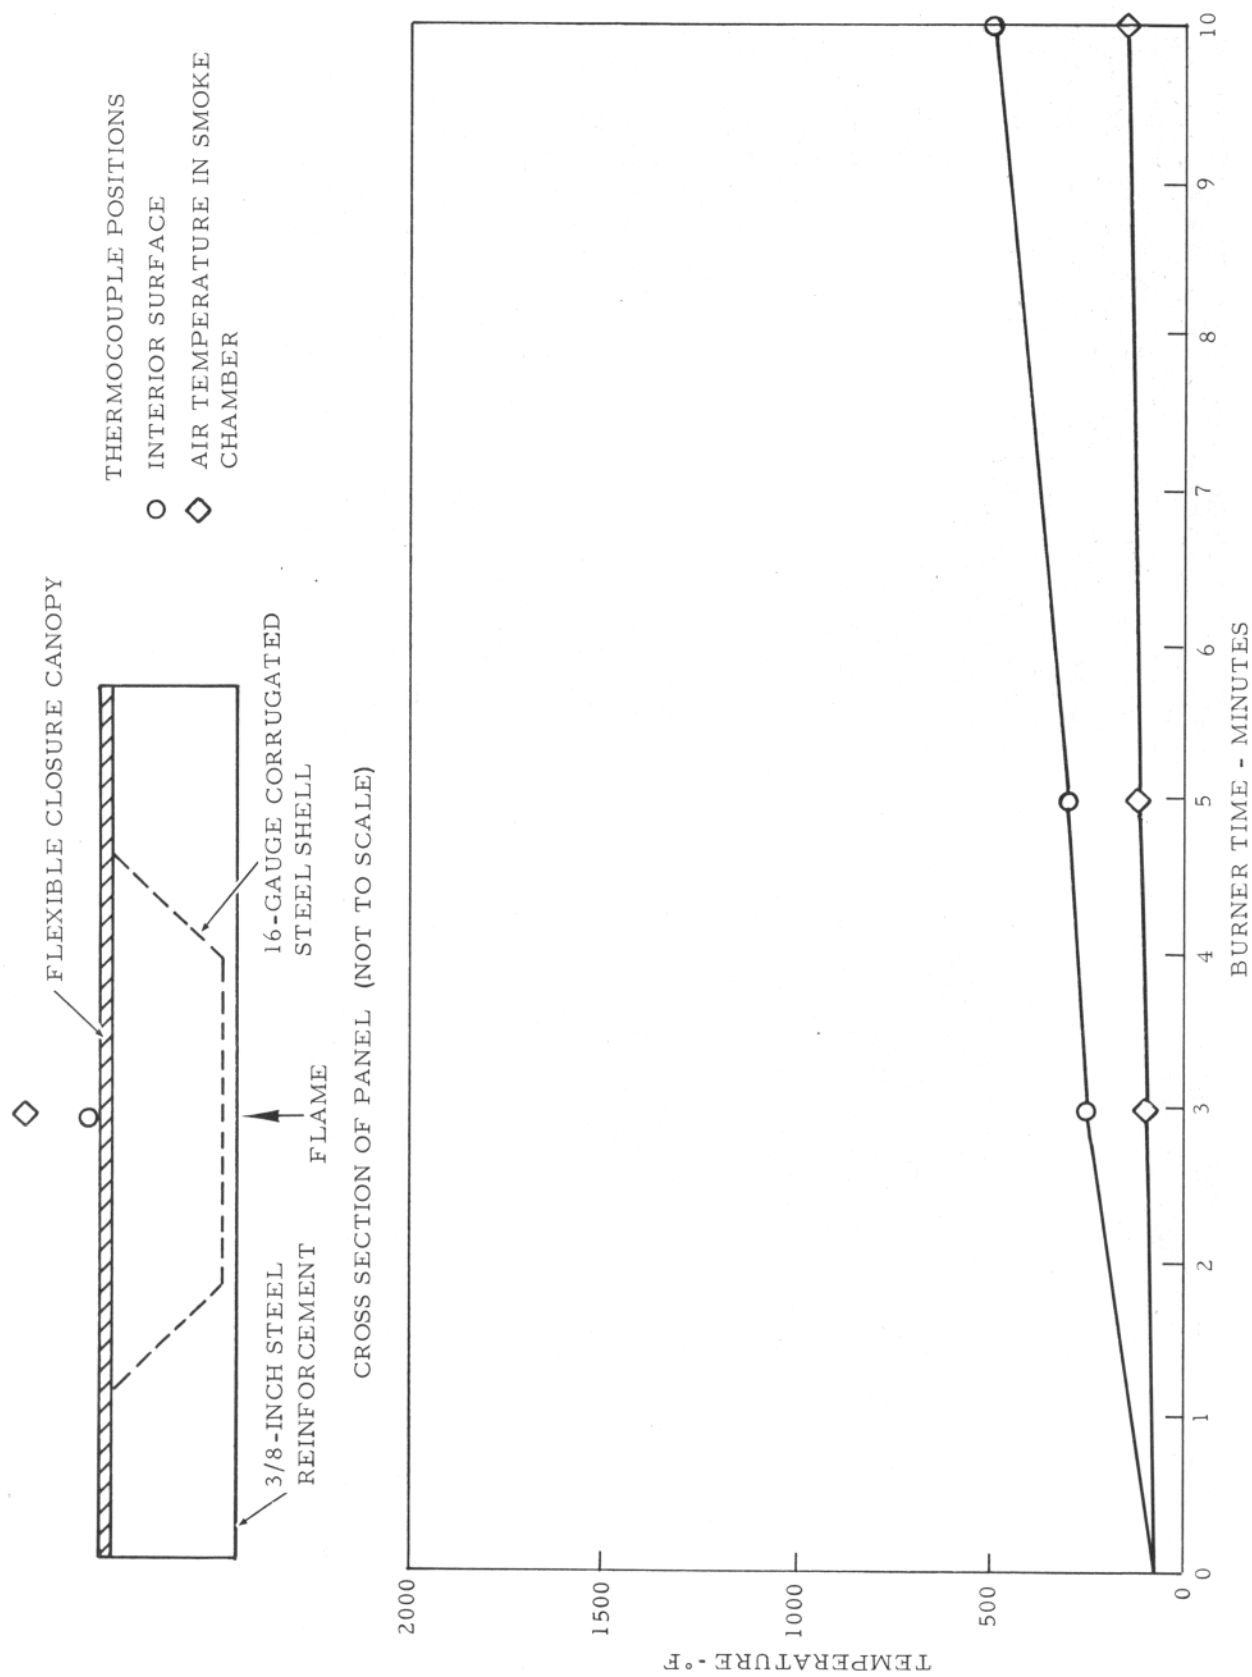
The effects of the burner flame impingement on the canopy material are indicated by the profiles in Figure 35 where temperature rise is plotted as a function of fire exposure time. From these data it is evident that the air temperature within the smoke chamber remained relatively low, reaching 110°F after 5 minutes and a maximum of only 130°F at the end of the 10-minute fire exposure period.

FIGURE 35. THERMAL EFFECTS ON THE WALKWAY CLOSURE CANOPY AS A FUNCTION OF FIRE EXPOSURE TIME

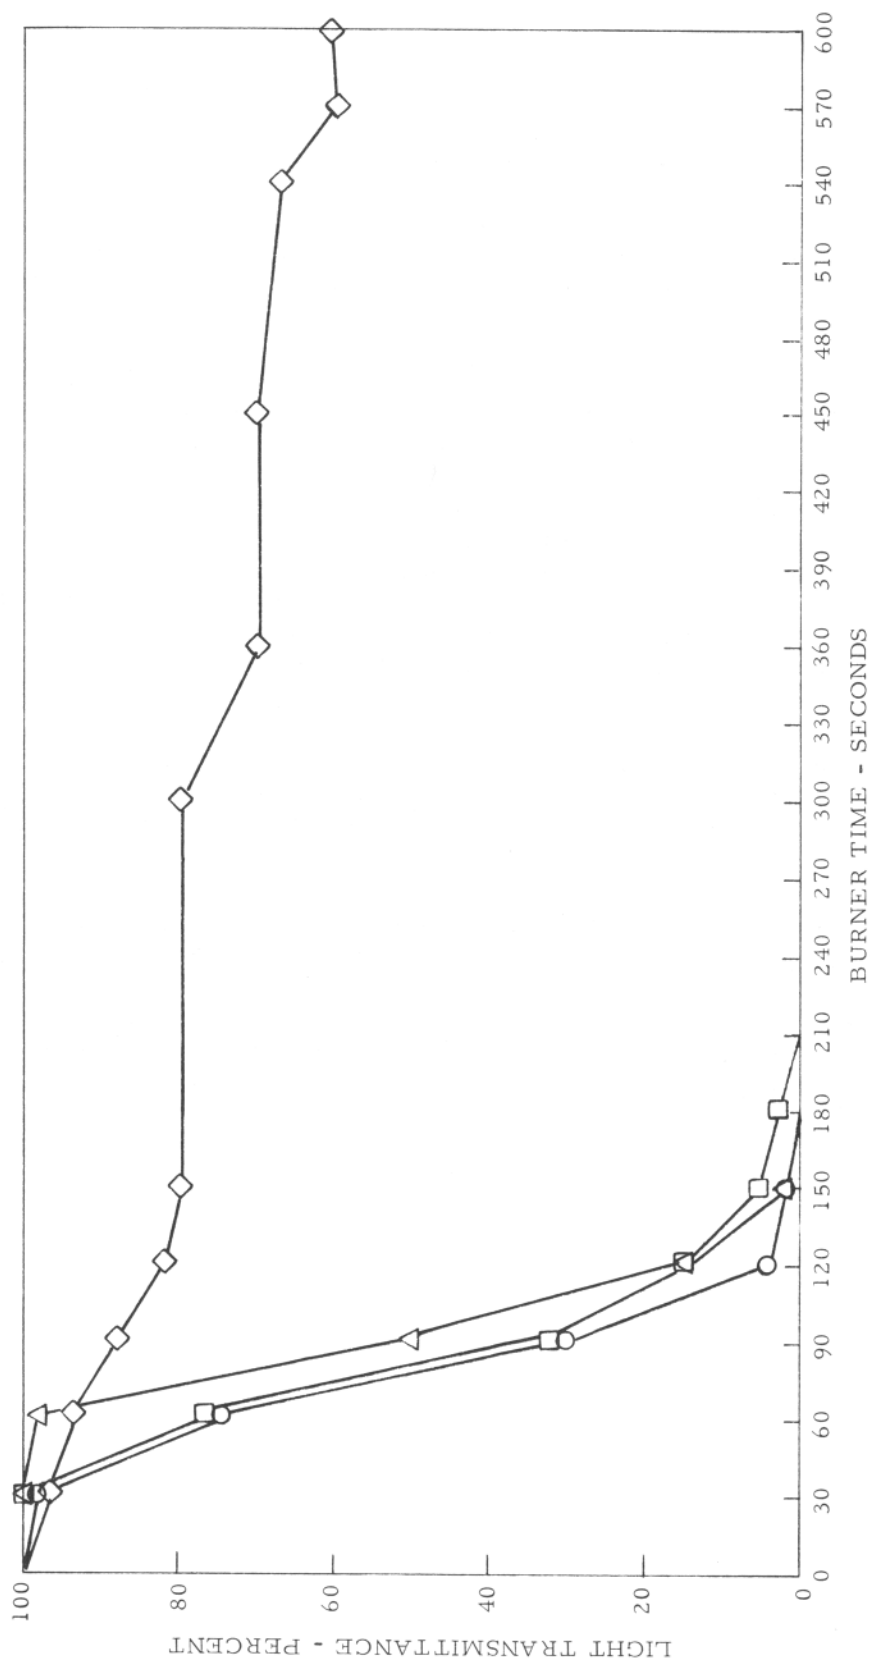
The overall results of the small-scale modified floor panel tests tend to indicate that, by employing a thermally stable structural floor panel or by providing adequate thermal and structurally stable insulation between the corrugated steel and plywood flooring, the quantity of pyrolysis products and smoke can be controlled to assure adequate visibility and maintain satisfactory walkway environmental conditions to provide for safe passenger egress over a period of 5 minutes or longer.

FIGURE 39. SUMMARY OF THE SMOKE DATA FOR THE MODIFIED FLOOR SAMPLE CONFIGURATIONS
